# Aeroplane Upset Recovery Training

## History, Core Concepts & Mitigation

**A Specialist Paper developed by**  
The Flight Operations Group (FOG)  
FOG Watch Publications  
Editorial team

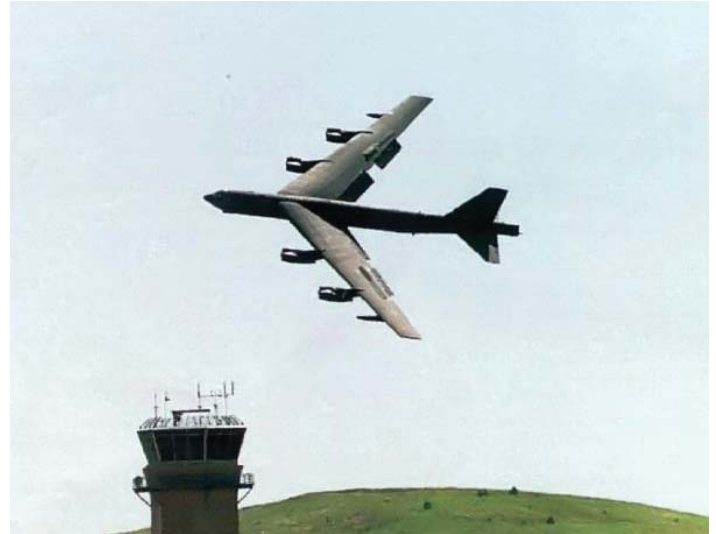
**The B-52 on its final steeply banked 360° turn, round the control tower, with flaps and spoilers deployed.** From Wikipedia, the free website encyclopaedia.

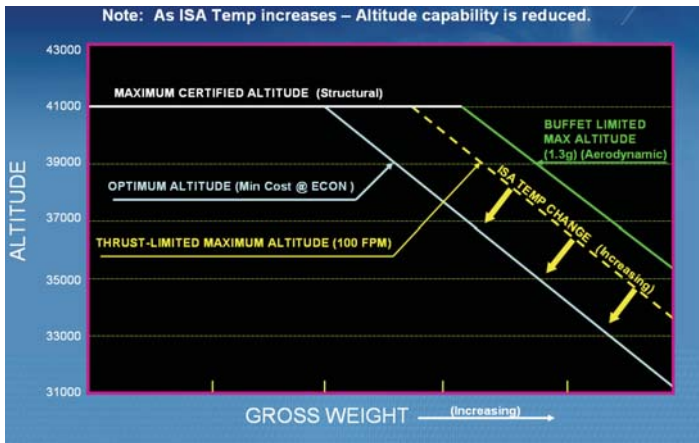
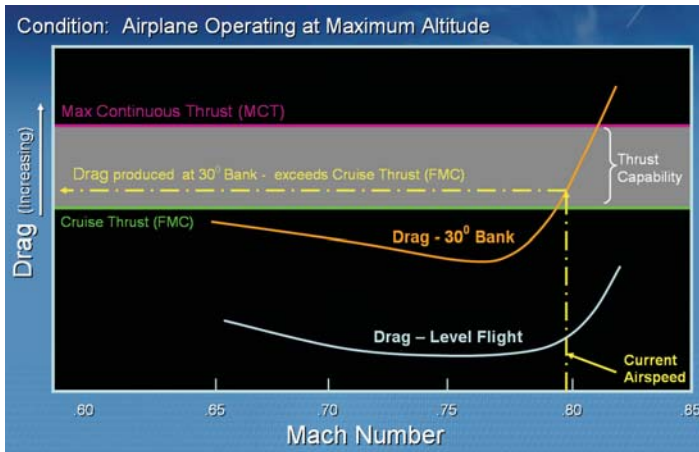
Figure 9.

When operating jet transport aeroplanes at the Thrust Limited Altitude it is important that crews be aware of outside air temperature and thrust capability. Pilot situational awareness requires knowledge of the Tropopause Altitude which may result in a temperature inversion which in turn may reduce the Thrust Limited Altitude. To avoid losing airspeed when at the Thrust Limited Altitude, good airmanship dictates that the Bank Angle programmed by the Flight Management system is monitored. If this is greater than 15°, consider limiting it to 15° of bank by using 'Heading Select', Ensure reselection of FMC/Navigation mode when the turn is complete. Normal bank angle selection [FMC bank angle limit is normally 30°] is satisfactory when flying at Optimum Altitude as the protection above the stall is not less than 1.5g. The two Figure 9 graphs illustrate the variable maximum altitude capability conditions for an aircraft, affecting their choice.

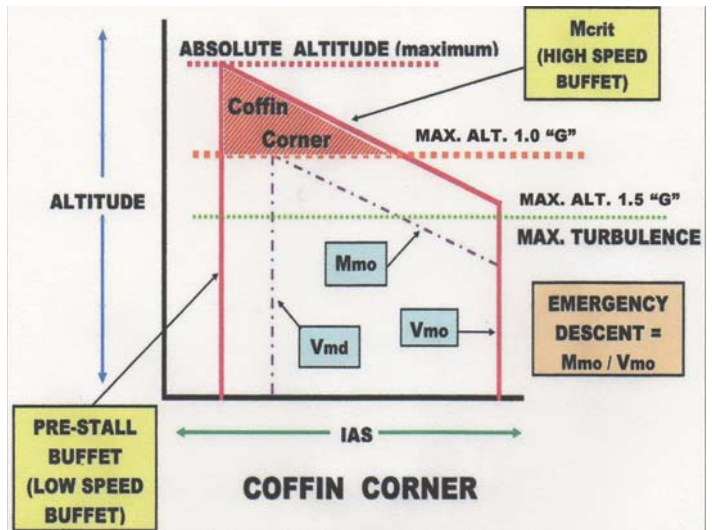
Figure 10. Capt Christopher 'Chris' N. White, FRAeS.

Figure 10 is a training slide used in class when addressing the subject of flight in 'Coffin Corner'. It is generalised and only used to introduce and explain the various limitations of the buffet envelope, for easier assimilation and retention. It does not

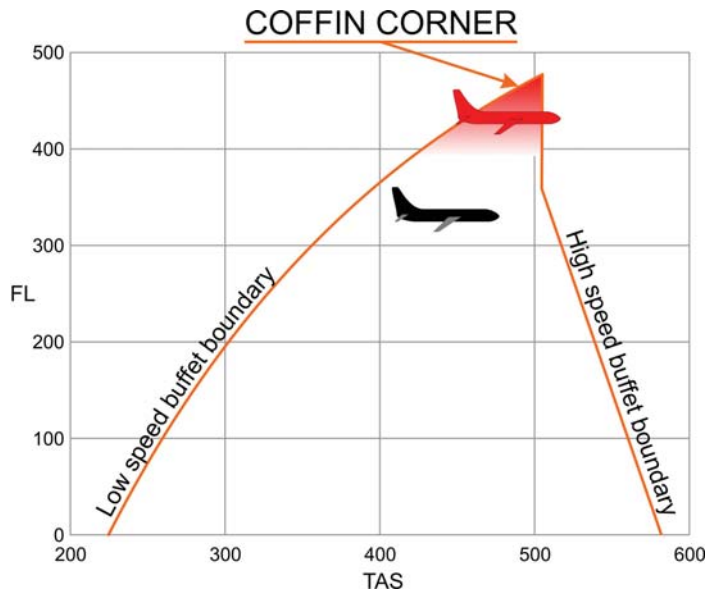
Figure 10(a). Capt Phillip 'Phil' H.S. Smith, MRAeS.
